RESSURECTING ATSF TANK CAR 100221

by Don Harper

Galveston Railroad Museum Volunteer and Advisory Board Member

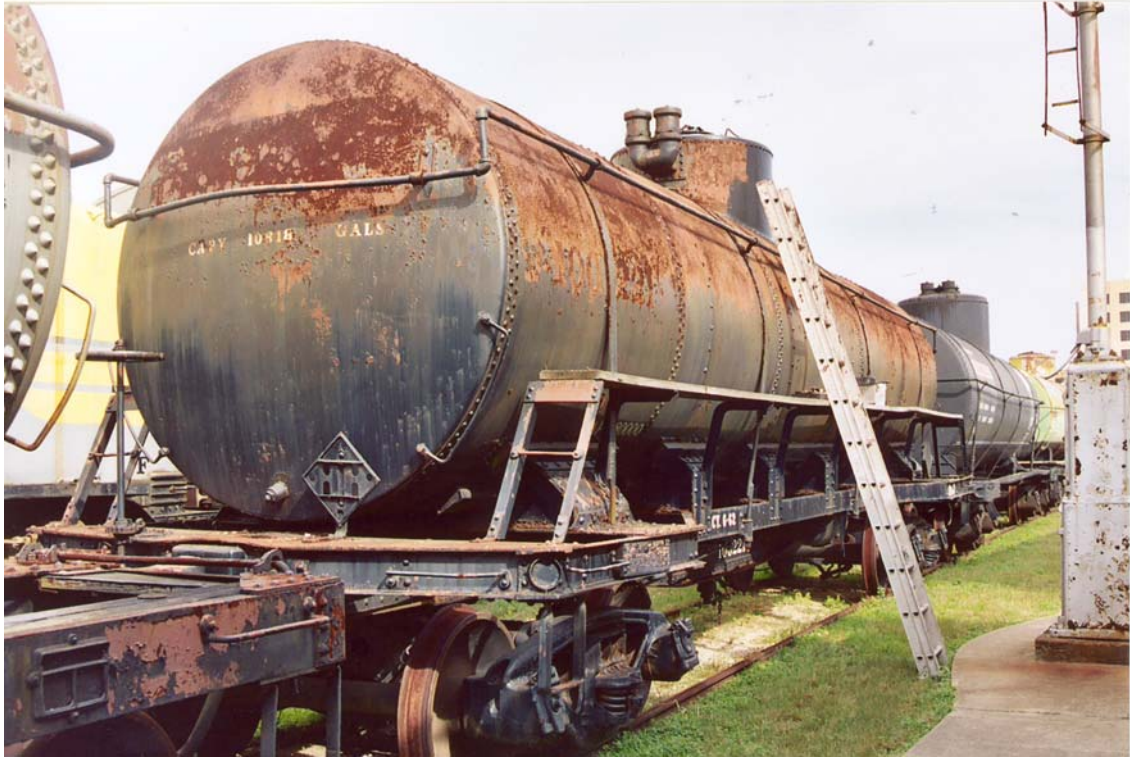
By 2005, time and Galveston's maritime climate had taken its toll on ATSF 100221. Much of the car's paint was gone, particularly on the upper surface of the tank, and the remaining paint had been weathered to a dull black having a slight greenish tint. Rust had pitted the surfaces in many places, had obliterated some of the markings, and there were several places on the lower quarter of the tank on both sides where the metal had rusted through to the inside. There is no telling how long since the car had been treated with any care at all. It was more of a prime candidate for the scrap yard than for a restoration effort (Figure 1).

Figure 1. ATSF 100221 as it appeared in January 2005.

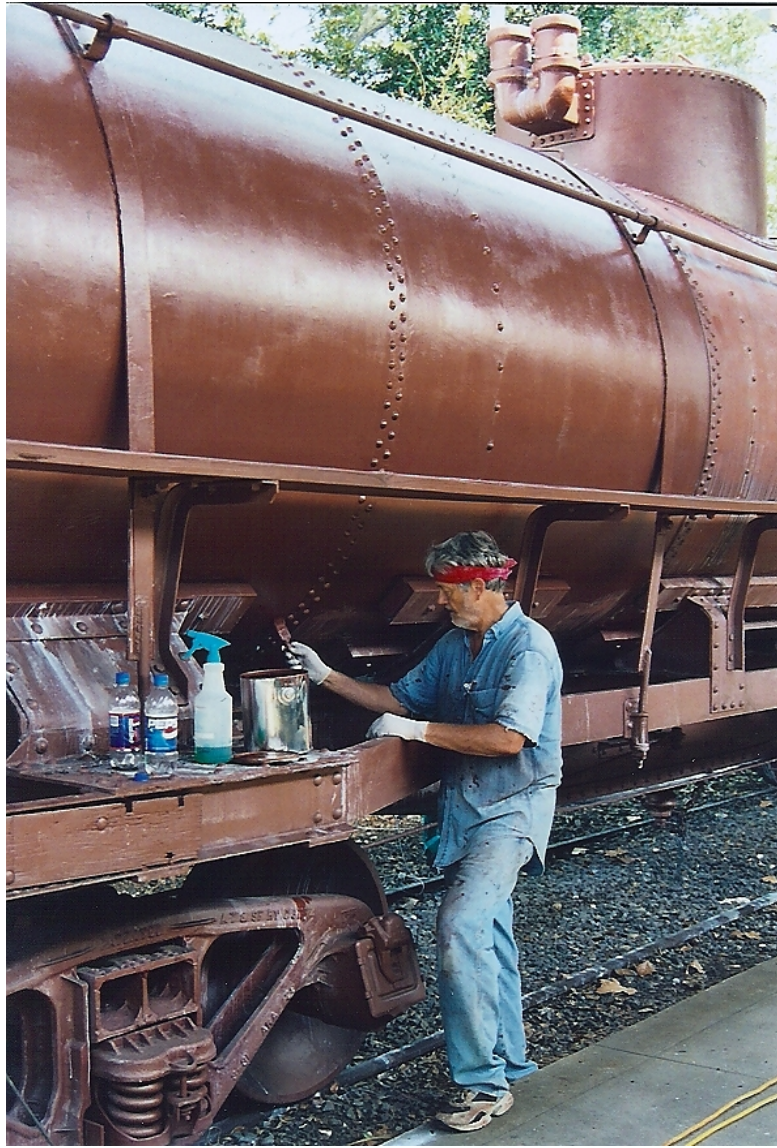
Figure 2. Don Harper priming the belly of the tank car on a hot day in September 2006

I began the restoration effort in May 2005 and first worked on everything above the running boards. I used sanding disks and wire wheels on an electric drill to remove paint and rust. This was much slower than sand blasting or a needle gun, but I had learned in earlier restoration efforts that older markings under paint could be carefully uncovered using my equipment. Paint was removed down to at least the primer, or if both were gone, down to bare metal. Each day, after an area was cleaned, I applied rust converter, and then primed it the following day (Figure 2).

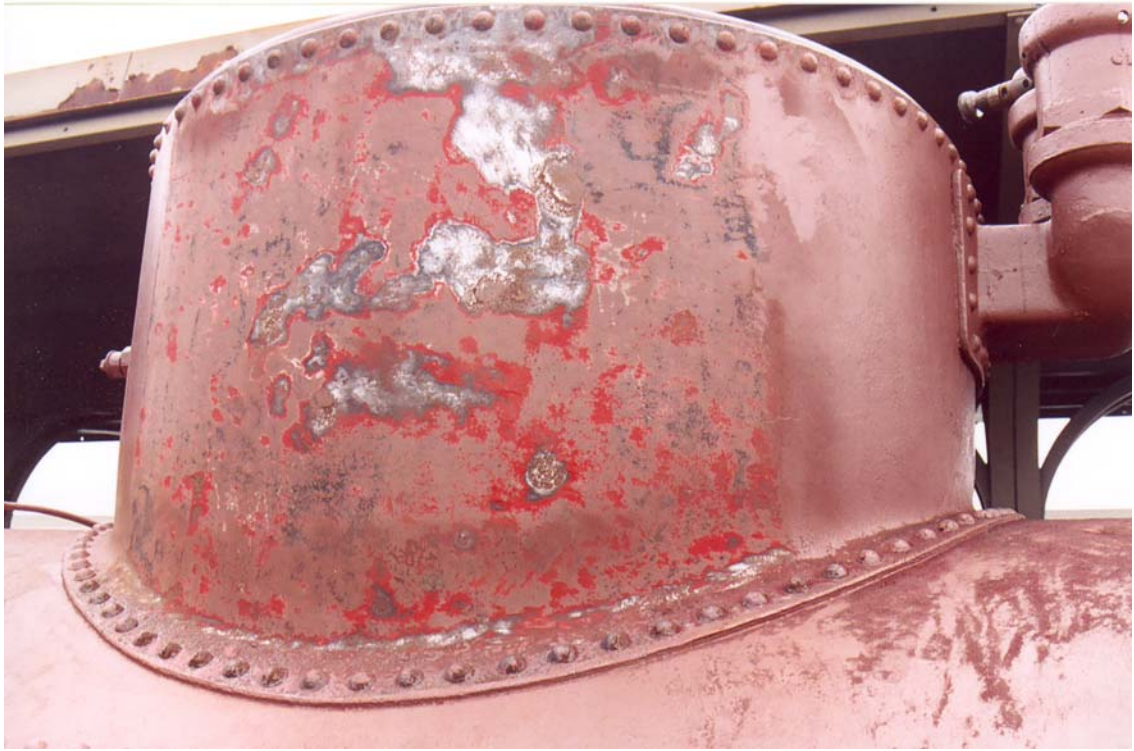
Stencils on the tank indicated the car's most recent use was to transport diesel fuel. However, as I removed paint from the second "section" of the tank (between the first tank strap and next series of rivets) at the right end (as you face the car), I found red paint beneath the black paint and primer. The red paint turned out to be a red band that extended from the midline at the top of the tank to the top of the first tank support board. Traces of the same red paint were also found on the dome (Figure 3). The ATSF used color coding from the mid-1940s to May 1977 to denote car contents. The red color band indicated the car had been used to carry gasoline; this use was confirmed when I uncovered a white "GASOLINE" stencil over the red band on the car's left side (Figure 4). I was very judicious in the use of sandpaper on the red bands, keeping as much of the original paint in place as possible. Just in case someone in the future wants an original color paint chip.

Figure 3. Dome of 100221 showing traces of red paint

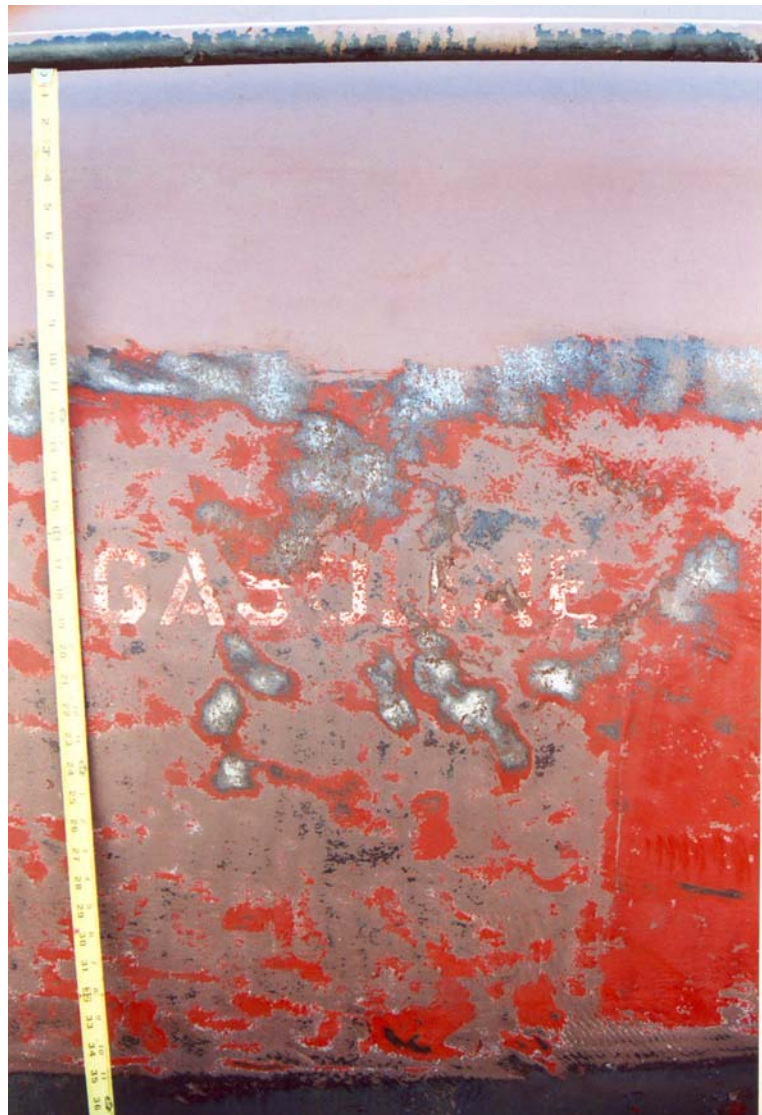
Figure 4. Left side red band showing GASOLINE stencil.

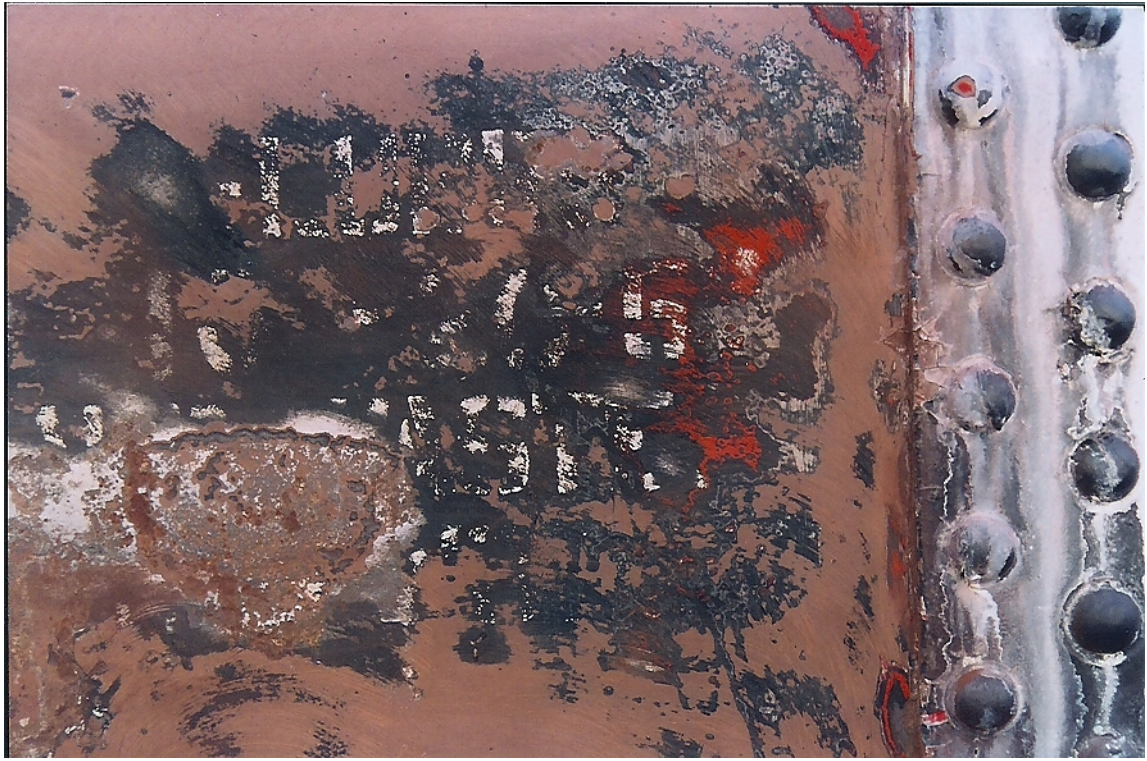
Just to the right of the left side red band, I uncovered some stencils that have not been completely interpreted. The top word appears to be LUBE and they may indicate when the last lubrication was done, similar to a COTS stencil on modern cars. Unfortunately there was a lot of rust in this area and several letters were destroyed (Figure 5).

Figure 5. Stencils on the left side, to the right of the red band. The red is overspray from the band.

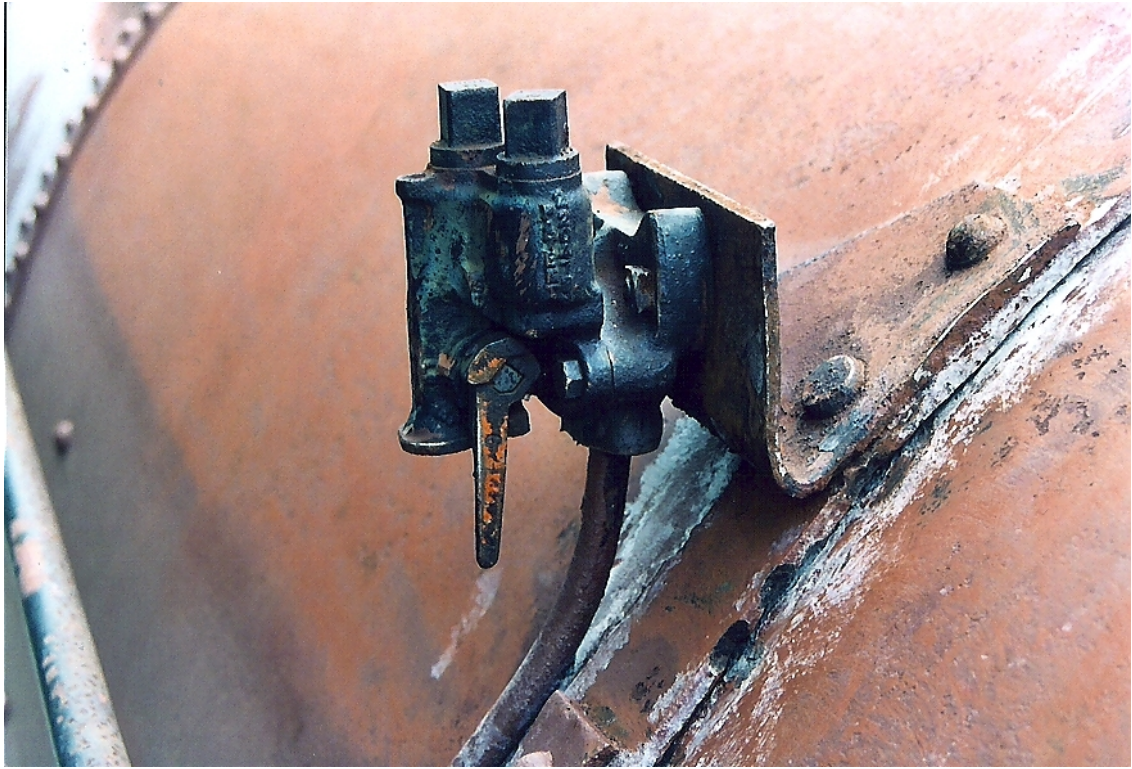
When I cleaned the retainer valve handle, I found orange paint under the black paint (Figure 6). Richard Hendrickson informed me he had found only one photographic instance of a valve handle with this color.

Figure 6. Retainer valve handle with remnants of orange paint.

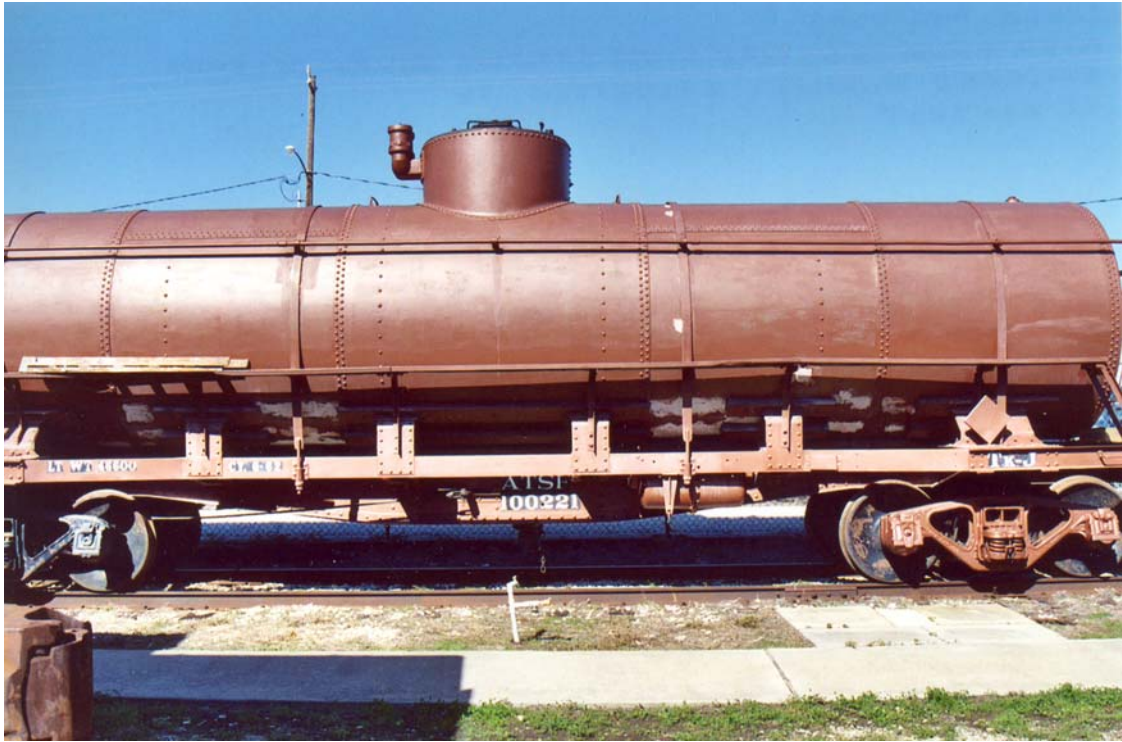
Figure 7. Right side of 100221 showing Bonded areas before priming. Note the large letters on the center sill.

Below the running boards progress was slower. There were several holes rusted through the tank, a couple of them large enough to put your hand through. I cleaned around these holes, applied liberal amounts of rust converter and then patched the holes in with Bondo. Bondo had to be applied over a several-day period to fill the larger holes. When the holes were finally filled, the Bondo was sanded smooth, and made to conform to the curvature of the tank (Figure 7.

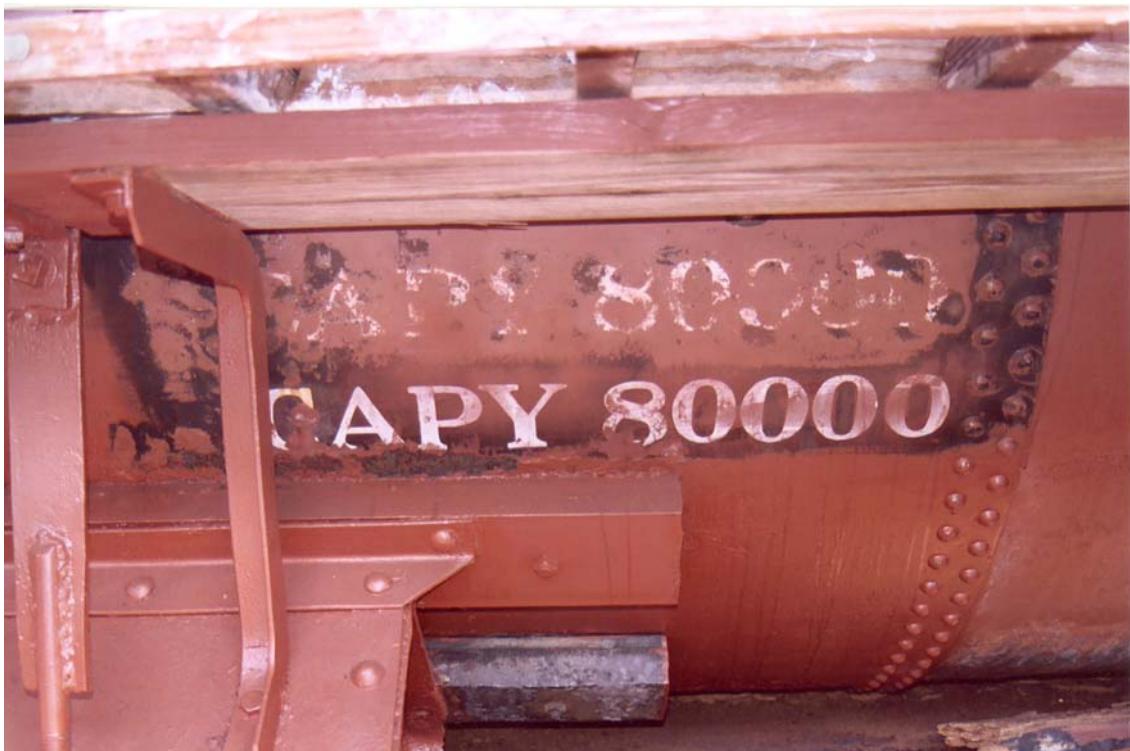
By carefully sanding, I uncovered the old CAPY 80000 stencils on the tank body. These were between the running boards and the tank supports, toward the left ends (as you face the car) of the car. The older stencils were just above the newer ones (Figure 8).

Figure 8. Older and newer right side, B end CAPY stencils

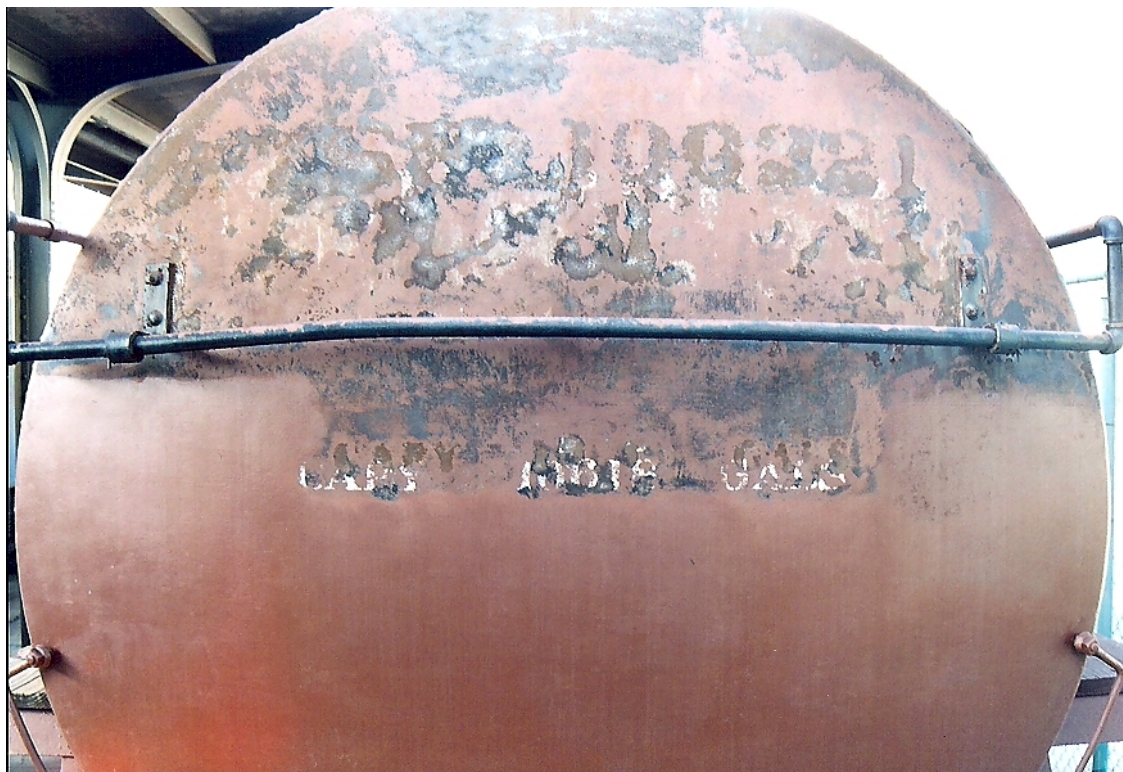
The B end of the tank was so badly rusted that only the CAPY marks remained. The A end was in a little better condition and the car number and CAPY marks could be seen. When these were carefully sanded, earlier stencils were found beneath them in approximately the same locations, indicating that the stencil locations did not change much during recent times (Figure 9).

Figure 9. A end showing older and newer car number and capacity stencils.

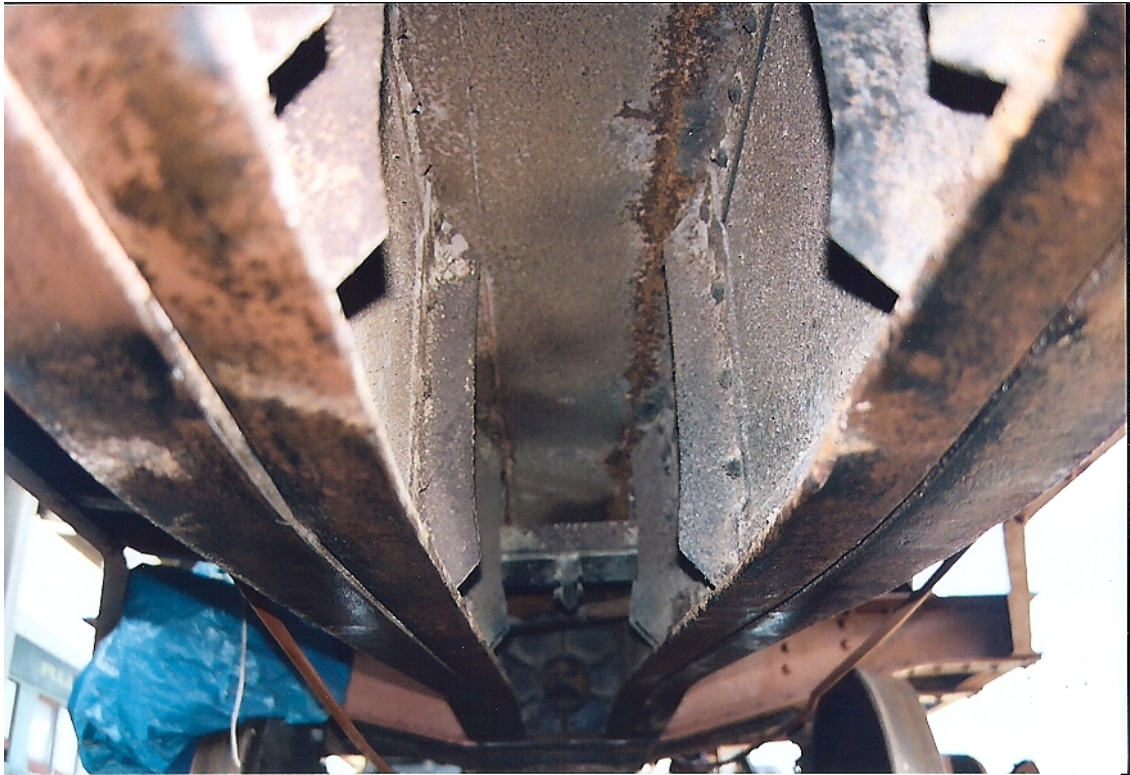
I had intended to only paint the parts of the frame that were visible, but once I crawled underneath and inspected the center sill and bolsters, I decided the remainder of the car needed to be cleaned before it was painted. There was considerable rust on the inside of the centersill, particularly along the upper plate seam (Figure 10), and the bolsters contained a lot of loose rust.

Figure 10. B end center sill before cleaning

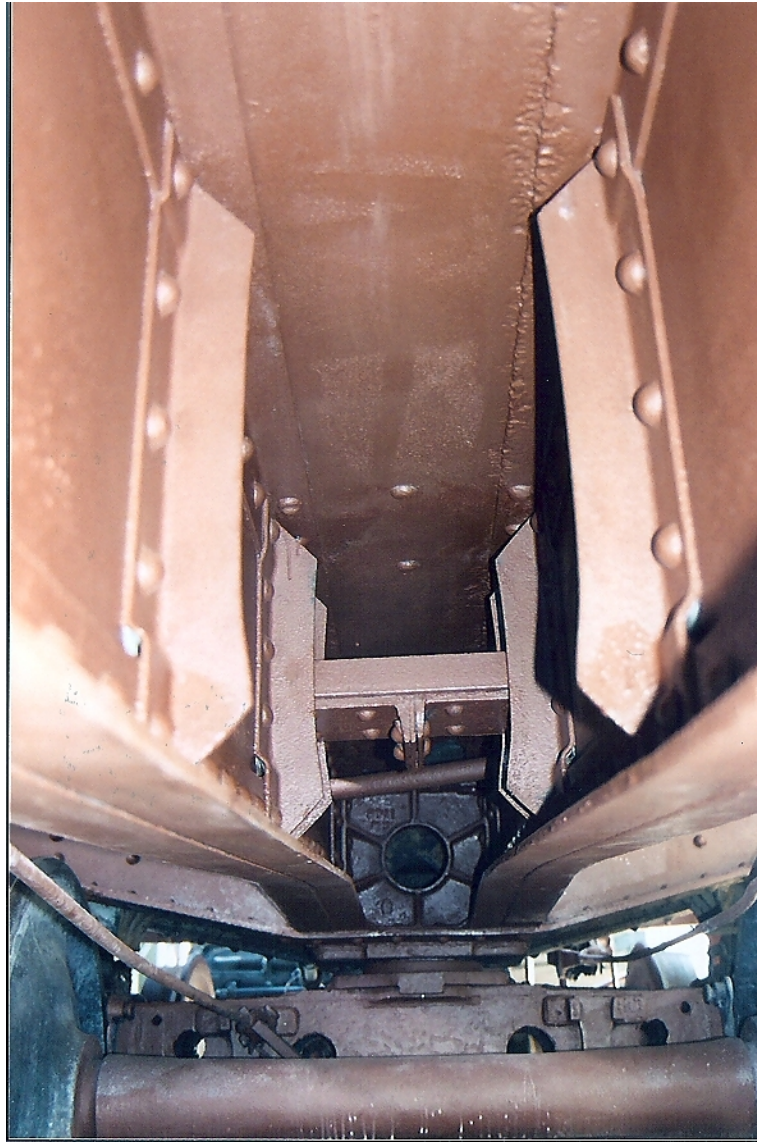
Figure 11. B end centersill after cleaning and priming.

The rust was ground away using a wire wheel, then the metal was sprayed with rust converter and primed (Figure 11)

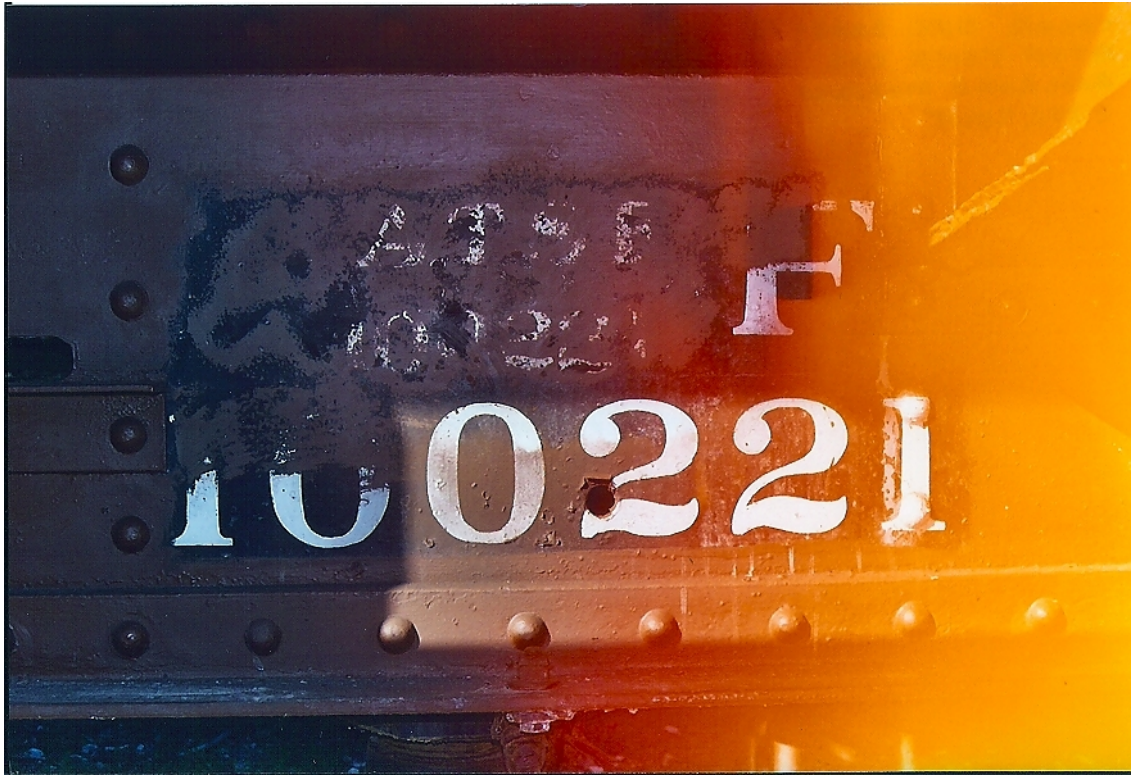
As I cleaned the outside of the center section of the fishbelly center sill on both sides, I carefully sanded away 4 inch tall letters and numbers and found older, 2 inch tall letters and numbers beneath the black paint. Note that the older stencil was identical on both sides of the sill (ATSF stenciled over the number), whereas the newer stencils were applied differently on the left and right sides (Figures 12, 13).

Figure 12. Right side center sill marks

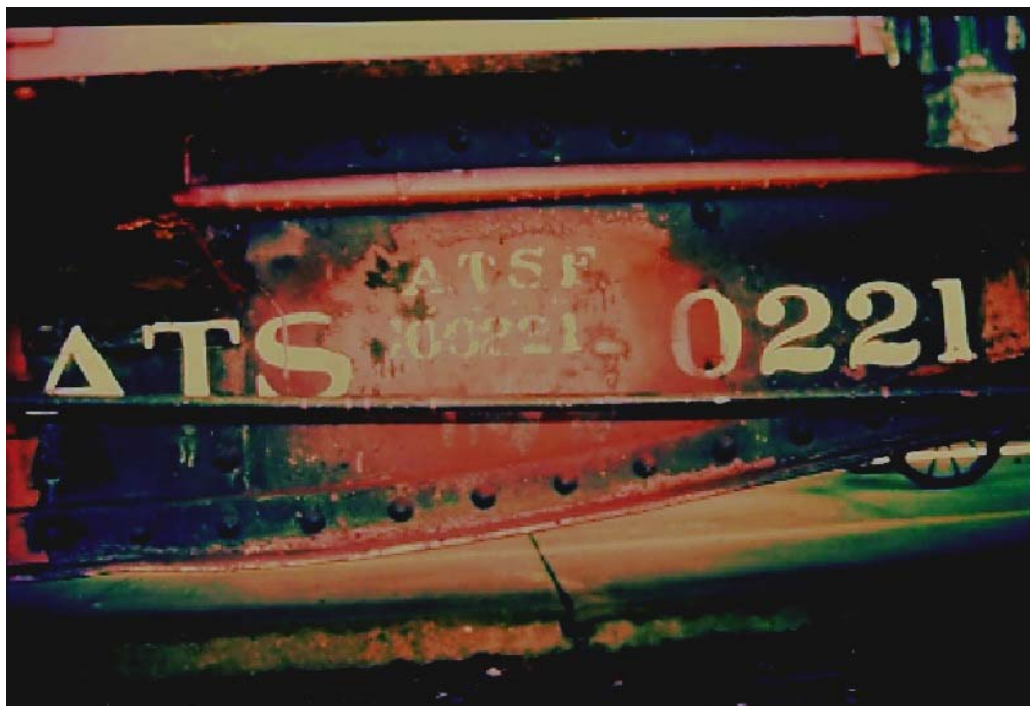
Figure 13. Left side center sill marks

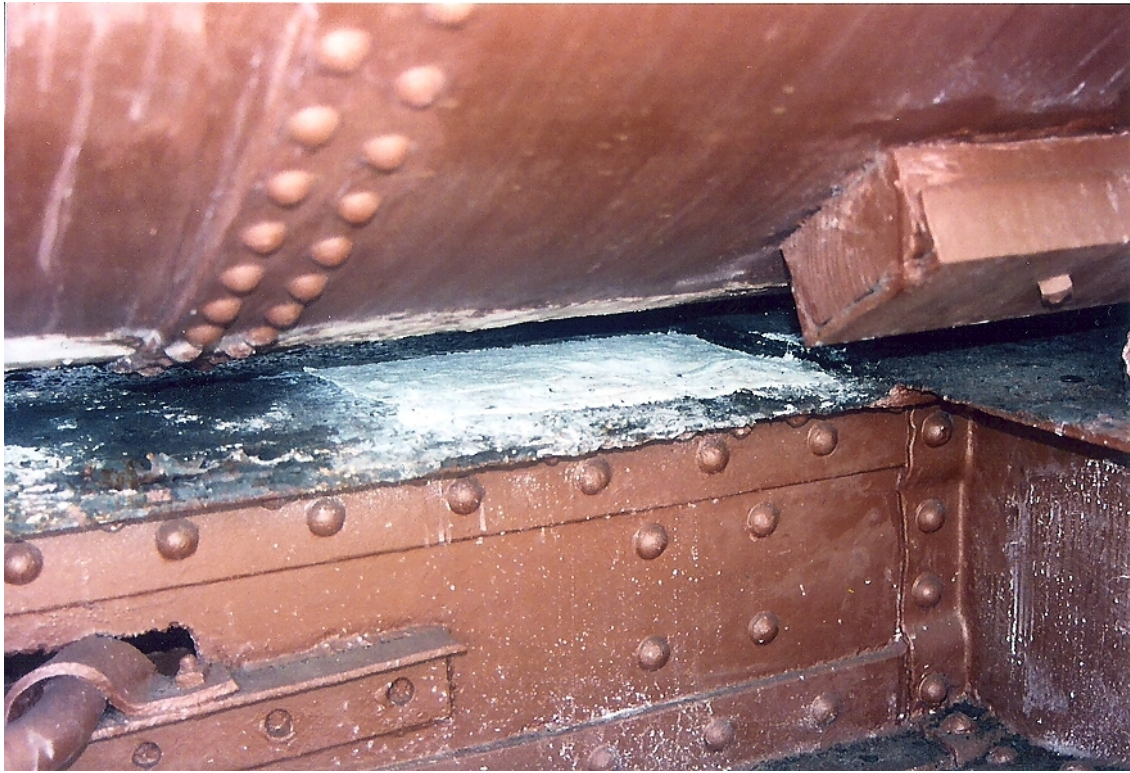
Figure 14. Rusted hole in the center sill plate patched with plaster cloth

The center sill deck plate had a large hole rusted through it toward the B end. Bondo would not stay on this horizontal surface, so I applied a piece of plaster cloth (Figure 14), let it dry, then spread Bondo over the patch. It took 3 applications of Bondo to get the depression filled in. The area was then sanded and primed.

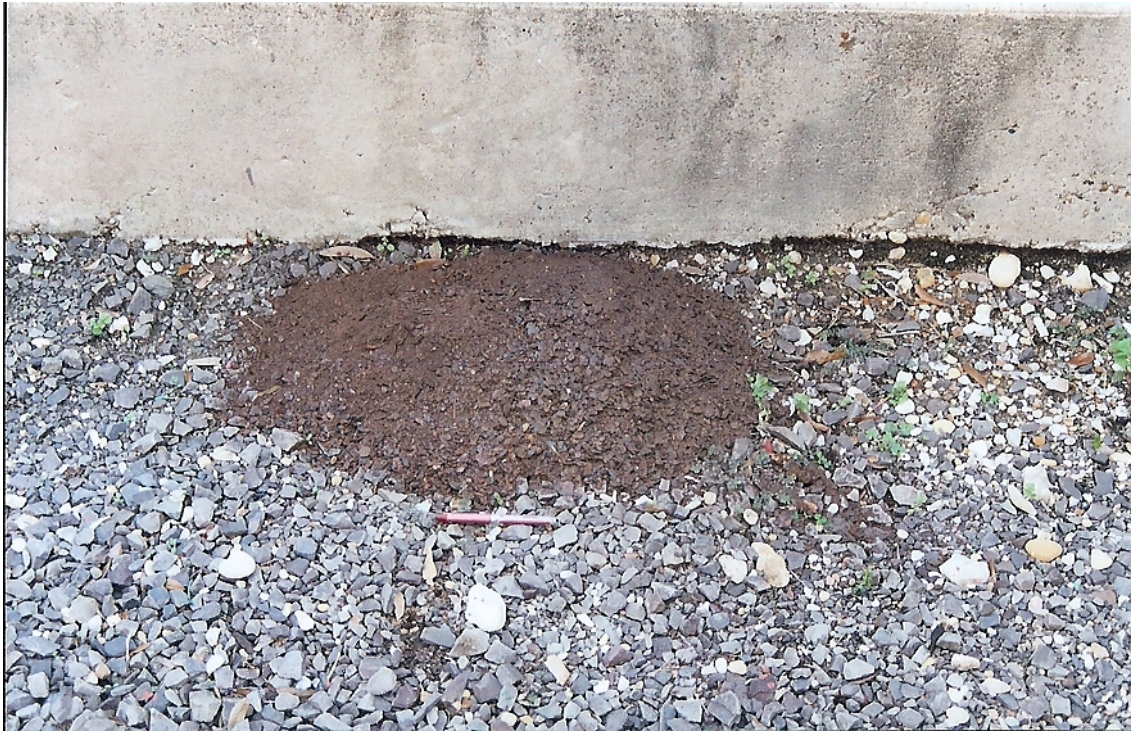
Figure 15. Rust removed from the B end bolster. The 6-inch pen is for scale.

Finally I worked my way down to the bolsters and trucks. On the outside of the B end bolster I found faint traces of the white paint used to stencil the road and car number. I tried to photograph these marks, but the camera's flash washed them out. There was a lot of rust and debris inside the bolsters and I spent several hours pushing a long shop vac hose in and out of the bolsters, sucking out the accumulated dirt and rust. Once the insides were free of loose rust I had our engine man back our switcher up and bang hard into the car a couple of times to knock rust loose that I could not reach, and then vacuumed that out. I estimated that about 10 to 15 pounds of "stuff", mostly rust, was removed from each side of each bolster (Figure 15). When cleaned, I sprayed Ospho all around the inside, then brush painted what I could reach and spray painted the remainder. The brake gear was also cleaned and primed.

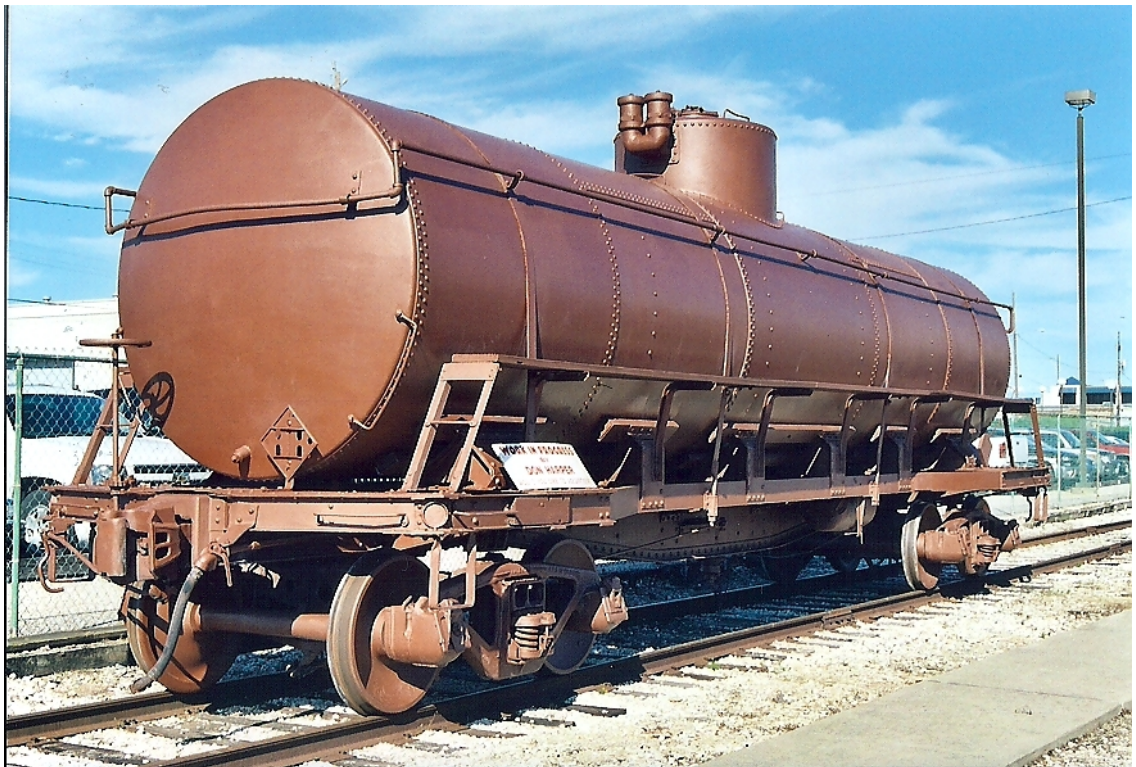
Figure 16. ATSF 100221, B end, right side, fully primed

Surface preparation required over a year, working part time, mainly on Saturdays and some weekday afternoons (I still had a real job when I started on the car). The car was fully primed in October 2006 (Figures 16, 17). I retired in August 2006 and thereafter devoted about 5 hours per day, 6 days per week, on the car.

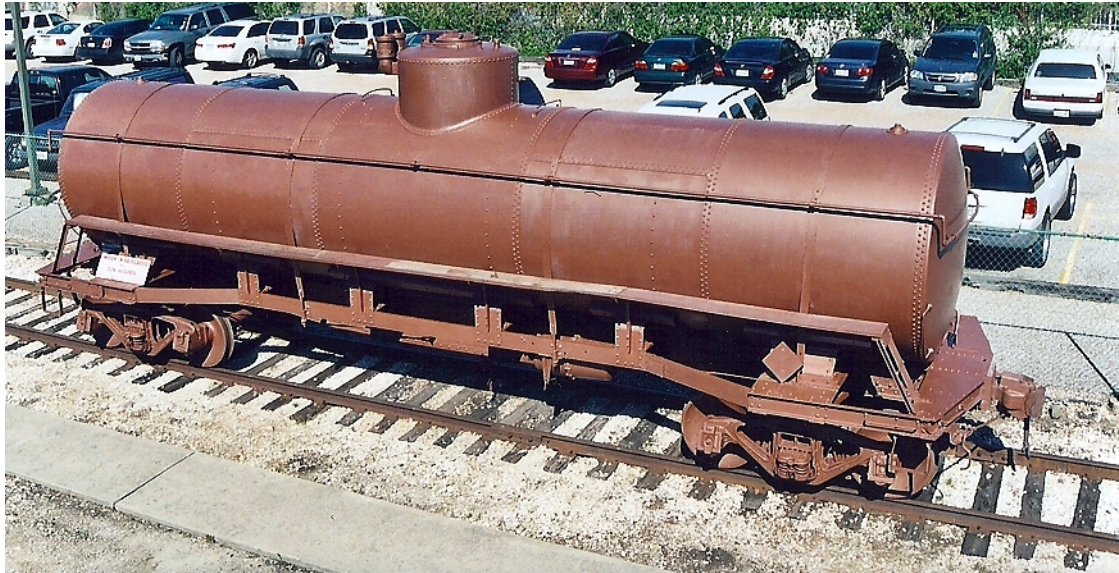
Figure 17. ATSF 100221 top and right side fully primed

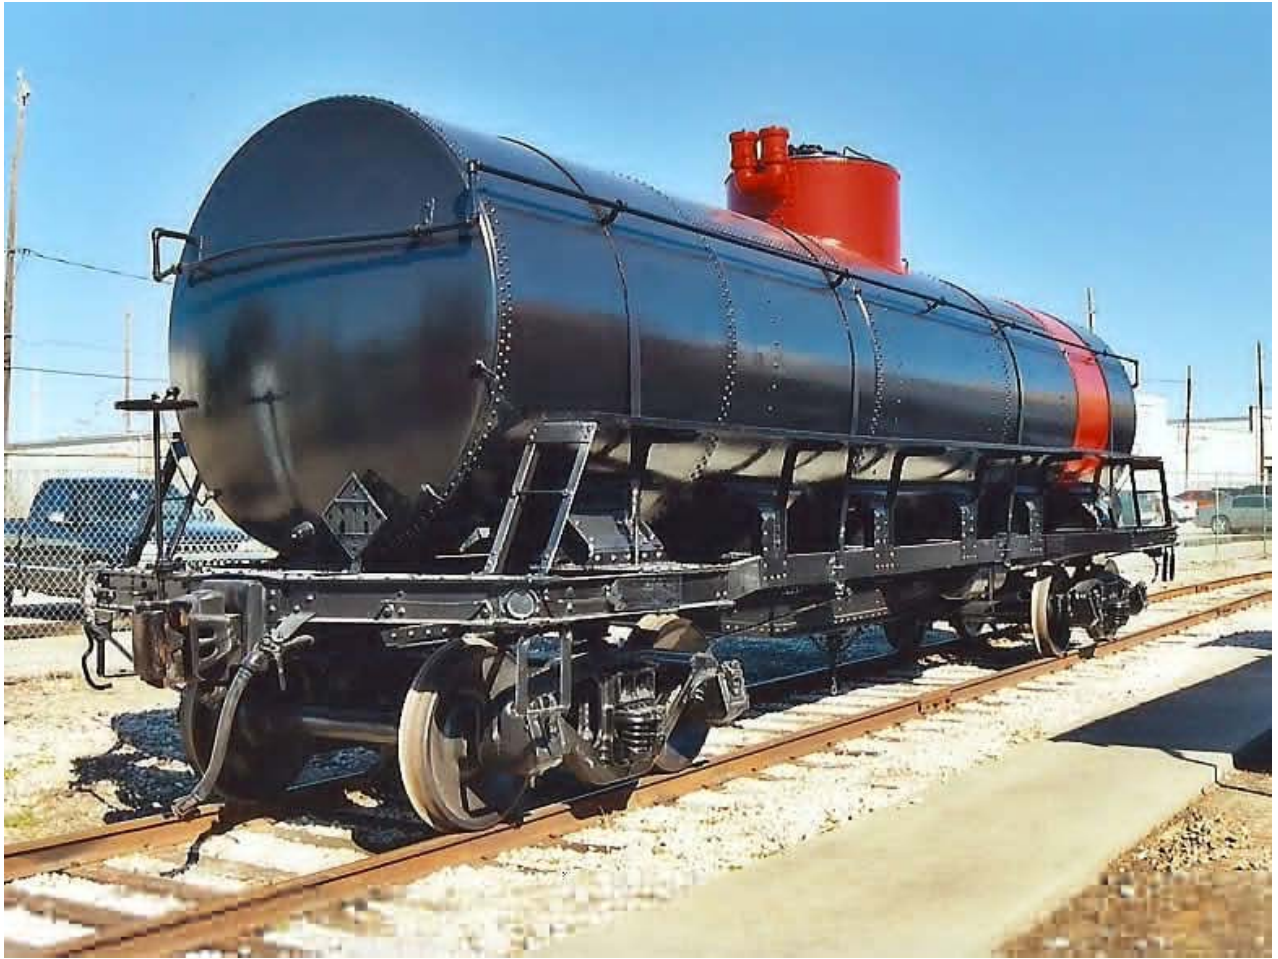
ATSF 100221 now sports its beautiful black paint job with red stripes and dome (Figure 18).

Figure 18. ATSF 100221 fully painted and awaiting stenciling.

I began painting in October 2006 and was completed at the end of December 2006. I started by painting the frame, trucks, bolsters and underbelly. Then I started on the tank proper. I backdated the car and repainted it in the black body with red band color scheme. I delimited the area to be painted red with painter's masking tape and painted the body black. After the second coat had dried, I removed the tape and applied new tape to the outside edge of the unpainted surface and applied two coats of safety red.
